STATE OF HAWAII
DEPARTMENT OF LAND AND NATURAL RESOURCES
COMMISSION ON WATER RESOURCE MANAGEMENT
 Stream Protection and Management Branch

FIELD INVESTIGATION REPORT

FI2008111702 (East Maui, Kano Koolau Ditch, restore)

Date of Field Investigation:	November 17, 2008	Time (24-hour):	1010 - 1500
CWRM Staff:	Ed Sakoda, Dean Uyeno, and Chui Ling Cheng		
Individuals Present:	EMI - Garret Hew (Water Resources Manager), Mark Vaught (Operations Manager), Henry Robello (Field Superintendent), and Nelson Akiu (Keanae Supervisor)		
Hydrologic Unit:	Piinaau (6053)		
Stream Name:	Kano Stream (tributary of Palauhulu Stream)

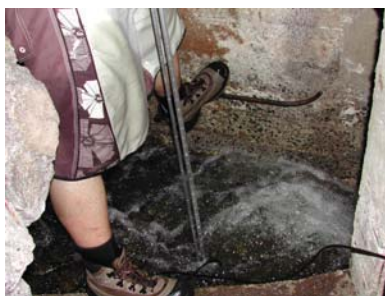
20081117046.JPG

According to the trip schedule, CWRM staff had planned to take flow measurements at Kano Stream near Koolau Ditch to estimate the amount of water that would be lost to the losing sections downstream from the ditch, before reaching IIFS Site B on Palauhulu Stream. However, the stream section near the ditch was mostly large boulders, without any well-defined sections suitable for flow measurements. Therefore, staff decided to take flow measurements near the Koolau Ditch bypass sluice gate to approximate the discharge that would flow into Kano Stream. Depth and velocity measurements were taken 3 feet downstream from the sluice gate at only three points along the cross section due to the turbulent flow conditions.

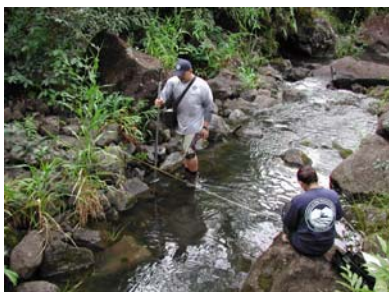
20081117061.JPG

On the drive back, CWRM staff stopped along Kano Road right before merging with Piinaau Road to access Palauhulu Stream downstream from Kano Falls and Koolau Ditch. Staff hiked from the road to the left bank of the stream, and continued to hike downstream. Staff located a suitable site for flow measurements and made necessary preparations. The site was not flagged because this location was not intended to be an IIFS site. Flow measurement was completed in 30 minutes. Staff recorded wind velocity, air temperature, water temperature and weather conditions. Weather was partly cloudy. As computed back in the Honolulu Office, the flow was 2.802 CFS (1.811 million gallons per day), with no gage height readings. Heavy rain began to fall as staff were hiking back to Kano Road.
